Appendix A: CIP Fact Sheets

Project Identifier	CIP #1
Project Name	Manhasset Storm System Improvements
Detailed Location	Manhasset Drive
Model File	HE_MA_ALT05.xp
Contributing Drainage Area	41.4 acres
Estimated Existing /Future Impervious %	64.0%/73.4%
Project Objective(s)	Increases System Capacity (Flood Control)

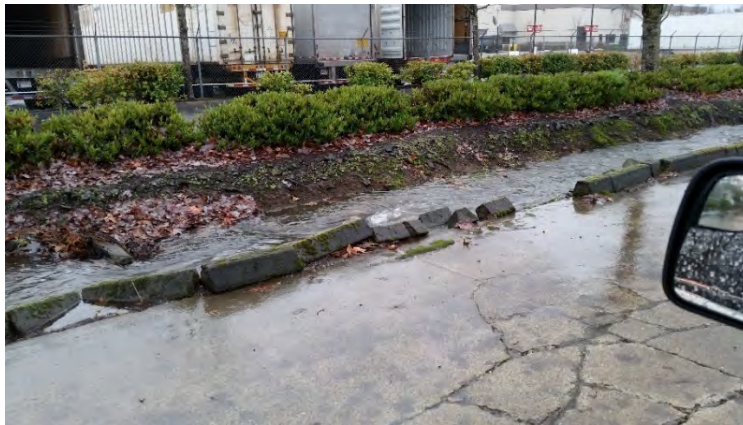
City staff and residents have reported frequent flooding of the open conveyance channel between private properties from Tualatin-Sherwood Road to Manhasset Drive. Stormwater flows have exceeded the capacity of the channel, overtopping the banks of the channel and impacting adjacent parking lots and structures.

Image 1. Observed flooding of drainage ditch during December 2015 storm

This project replaces the existing 1,050 LF of open channel and 180 LF of 21-inch-diameter pipe with 1,230 linear feet (LF) of 30-inch-diameter pipe. The project replaces the existing 750 LF of 27-inch-diameter pipe from Manhasset Drive to the outfall to Hedges Creek with 750 LF of 36-inch-diameter pipe to reduce potential flooding during the 25-year design storm event.

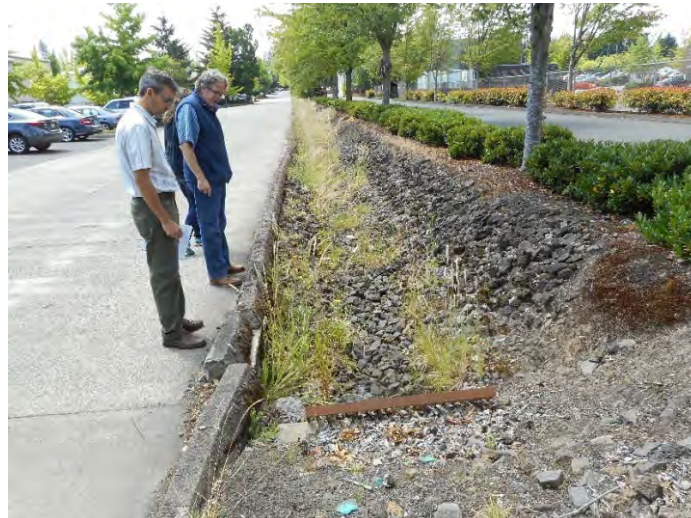
Image 2. Grated inlet and rock lined channel at downstream end of drainage ditch

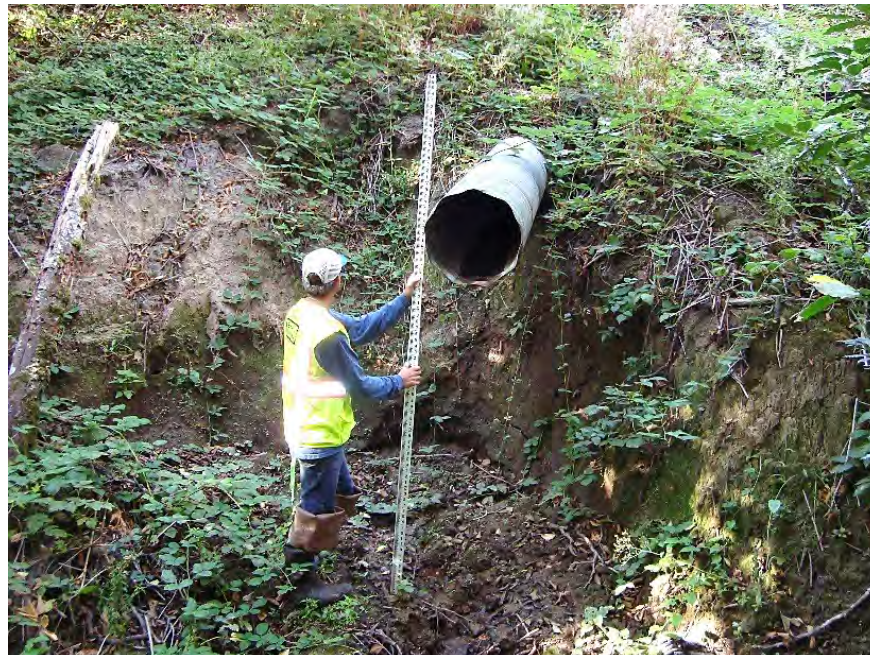
Image 1. Perched outfall from Blake Street with severe bank failure

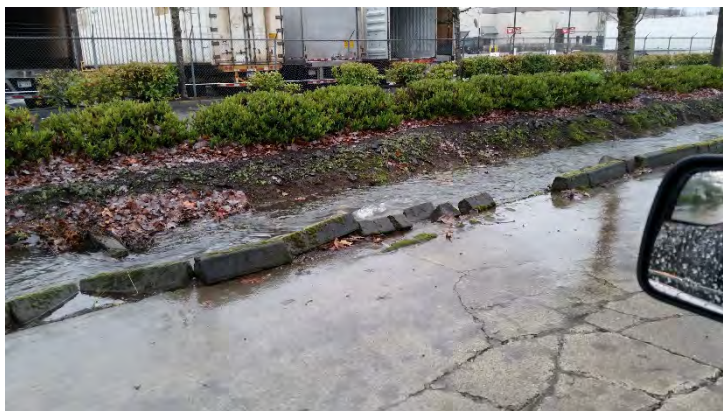
<p data-bbox="428 1083 1427 1213">Location: Manhasset Drive Open Channel Photo number: 1 Description: Flooding of open channel along Manhasset Drive during December 2015 storm event. Photo provided by City.</p>

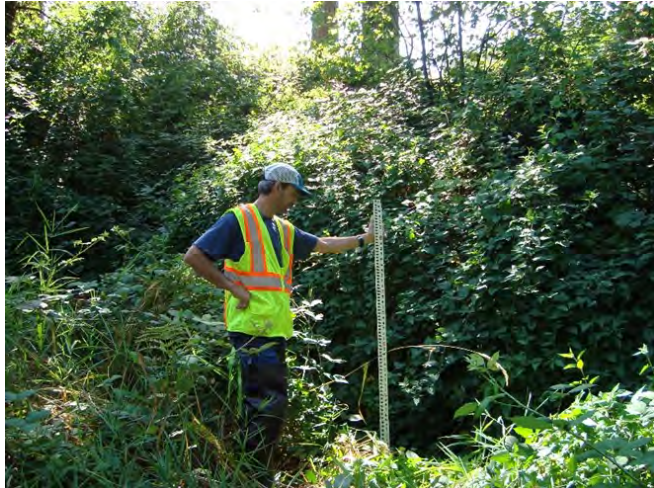
Typical photo of Hedges Creek Reach #2. Stream channel is overgrown with invasive vegetation. Channel is to the right and 4' below Ryan (standing on the bank). Photo location shown below with camera icon.

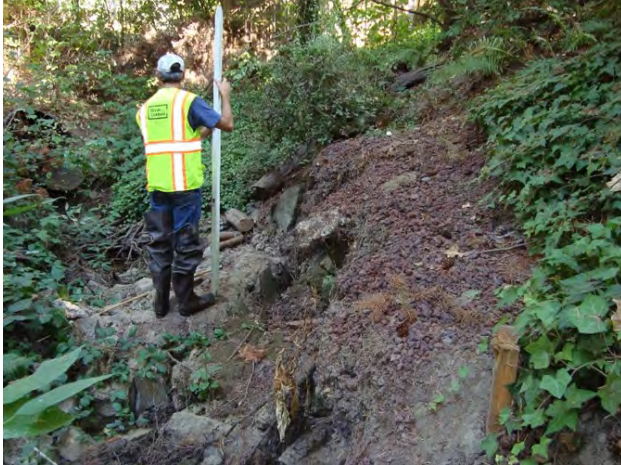
Unstable hillslope and debris in channel. Photo Location shown below with camera icon.

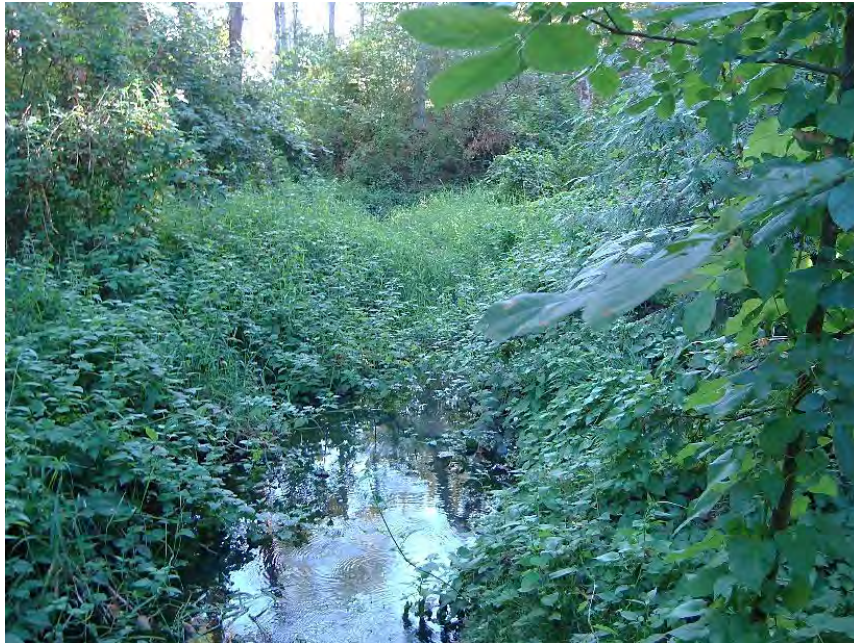
Site location: ~80' upstream of SW Blake St.
Photo number: S3-5
Description: Looking upstream, mucky conditions

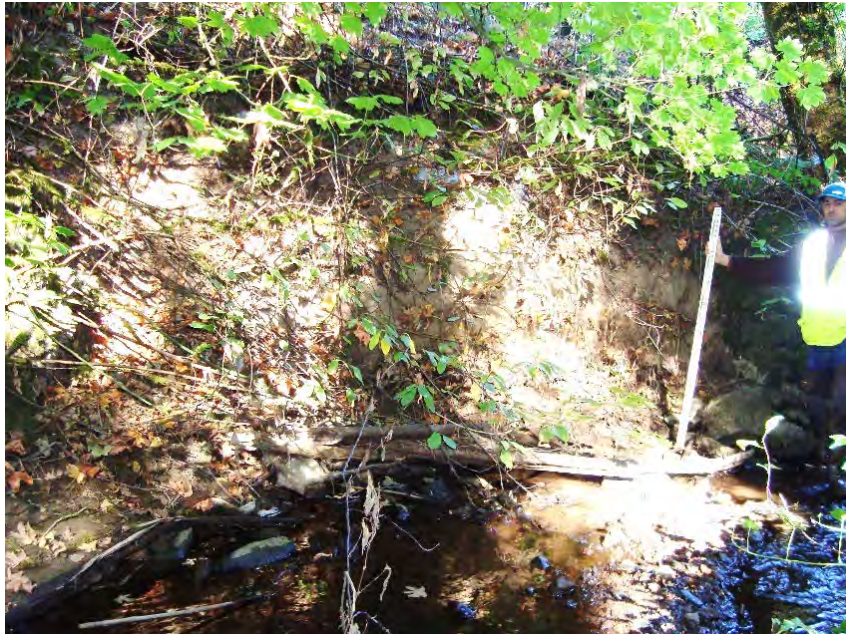
Site location: 175' upstream of SW 105th Ave.
Photo number: H3-5
Description: Left bank failure, missing wall segment adjacent to SW 105th Ave., outside bend
