Appendix A: CIP Fact Sheets

Project Identifier	CIP #1
Project Name	Manhasset Storm System Improvements
Detailed Location	Manhasset Drive
Model File	HE_MA_ALT05.xp
Contributing Drainage Area	41.4 acres
Estimated Existing /Future Impervious %	64.0%/73.4%
Project Objective(s)	Increases System Capacity (Flood Control)

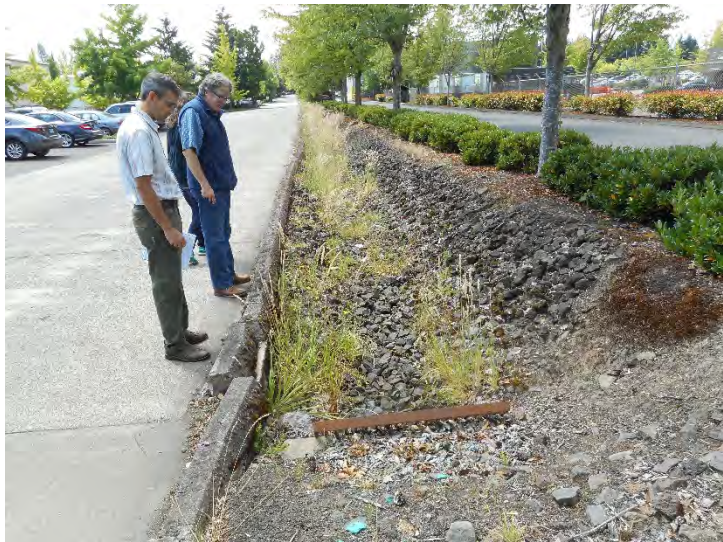
<p data-bbox="428 1774 1427 1841">Location: Manhasset Drive Open Channel Photo number: 2</p>

<p>Hydraulic Model System</p>	<p>Manhasset Drive</p>
<p>Description:</p>	<p>Open channel upstream of ditch inlet at Manhasset Drive. Channel bottom is rocky and has high roughness.</p>
<p>Location:</p> <p>Photo number:</p> <p>Description:</p>	<div data-bbox="430 346 1144 882" data-label="Image"> </div> <p>Manhasset Drive Open Channel</p> <p>3</p> <p>Debris in open channel is a restriction during rain events.</p>
<p>Location:</p> <p>Photo number:</p> <p>Description:</p>	<div data-bbox="430 1018 836 1554" data-label="Image"> </div> <p>Manhasset Drive Open Channel</p> <p>4</p> <p>Grated inlet at end of open channel segment along Manhasset Drive.</p>

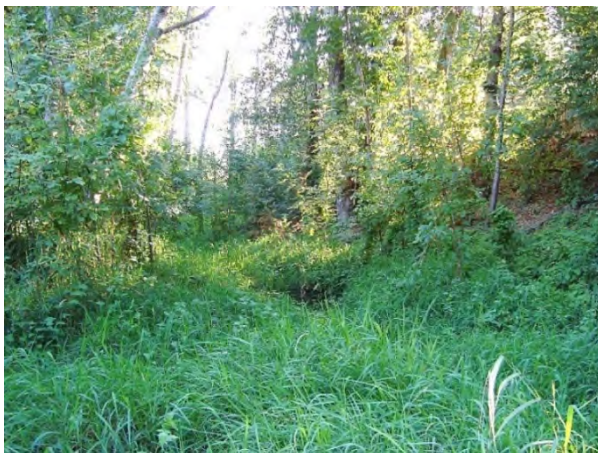
Photo 4. Saum Creek immediately upstream of SW Blake Street. Channel is obscured by reed canary grass. This area is very flat, and wet.

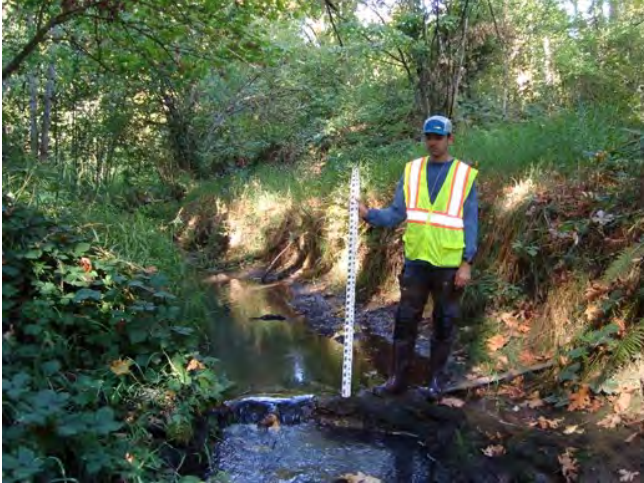
Hard clay forming pools within channel bed in Saum Creek Reach #2 (photo location shown below with camera icon)

Stream	Saum Creek
Reach	#2 (Lee St. to 65 Ave.)
General Characteristics	
Reach Length:	~4,950 ft.
Gradient:	~0.4 %
Floodplain Width:	~150' - 175'
Planform:	Meandering (Lee St. to SW 60th, straight (SW 60th to 65th Ave)
Average BFW:	~10' (range 8' to 15')
Average BFD:	~5' (range 3' to 6')
Substrate:	Silt, hard clay, occasional gravel
Vegetation:	Mixed floodplain forest (maples, alders, firs), reed canary grass, jewel weed, blackberries, ferns, willows, sedges
Beaver Activity:	None observed.
Issues:	No critical issues.

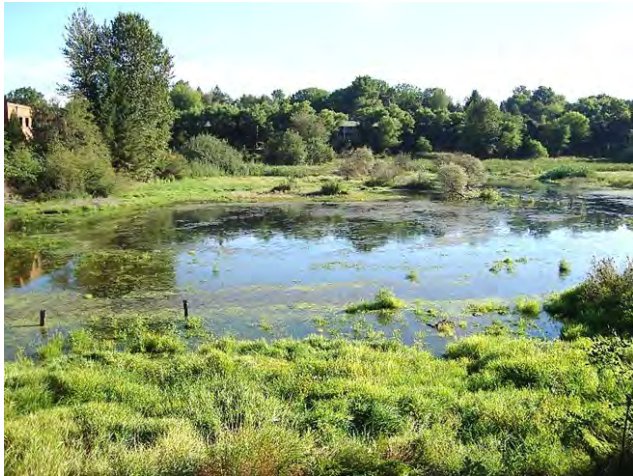
Nyberg wetlands between 65th Avenue and I-5
(photo location shown below with camera icon)

Stream	Nyberg Creek
Reach	#2 (65 Avenue to I-5)
General Characteristics	
Reach Length:	~2,100 ft.
Gradient:	~0.095%
Floodplain Width:	~500-650'
Planform:	Flooded, no channel.
Average BFW:	No channel. Not measured.
Average BFD:	No channel. Not measured.
Substrate:	Not evaluated. Flooded.
Vegetation:	Wetland plants, reed canary grass, duckweed, spiraea, jewel weed
Beaver Activity:	Extensive. Major beaver dam, and beavers observed during field visit.
Issues:	No critical issues.

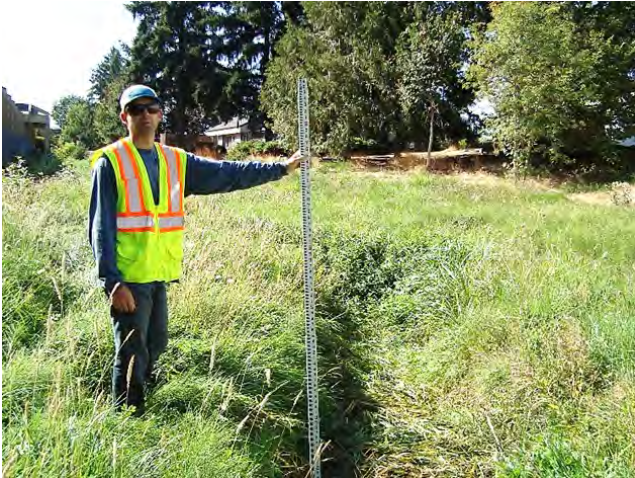
Nyberg Creek between Tonka Rd and Boones Ferry Rd. (photo location shown below with camera icon)

Stream	Nyberg Creek
Reach	#3 (Martinazzi Road to Boones Ferry Rd)
General Characteristics	
Reach Length:	~1,400 ft.
Gradient:	~0.29%
Valley Width:	~30-60' (channel is confined by development)
Planform:	Straight, confined by development
Average BFW:	~6.5'
Average BFD:	~2.5'
Substrate:	Fine silt.
Vegetation:	Dominated by reed canary grass, few deciduous trees.
Beaver Activity:	No.
Issues:	No critical issues.

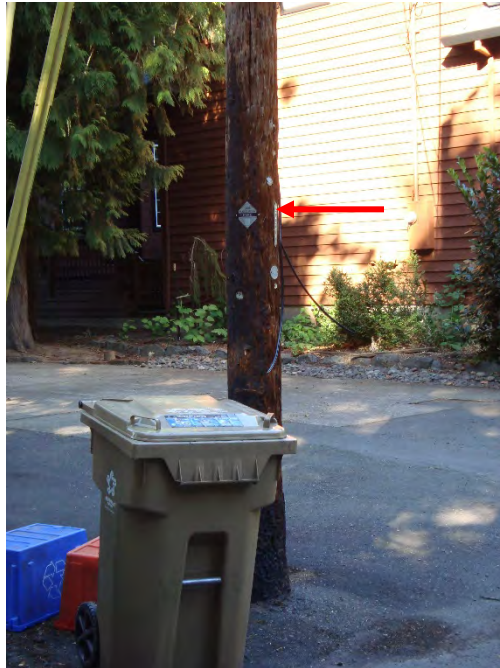
Site location: Near Tualatin River
Photo number: Tual-1
Description: Flood marker on utility pole (1996 flood). Red arrow shows marker location.

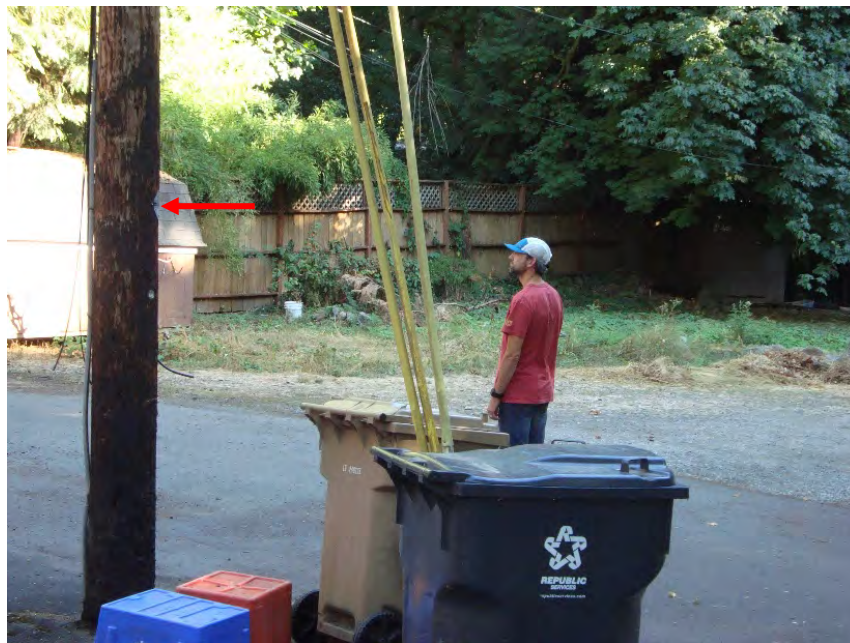
Site location: Near Tualatin
Photo number: Tual-2
Description: View of utility pole with flood marker (1996 flood). Red arrow shows marker location.

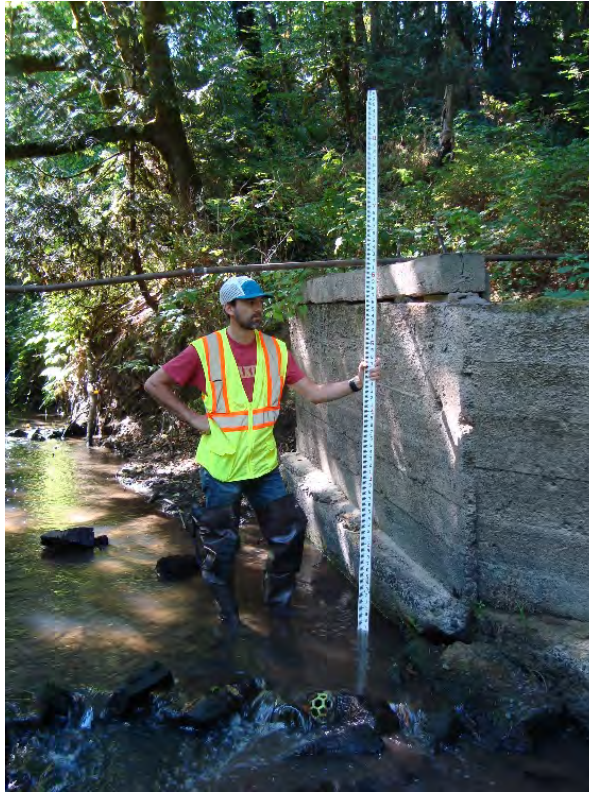
Site location: ~200' upstream from Tualatin
Photo number: S1-3
Description: Former bridge abutment, looking upstream at left bank

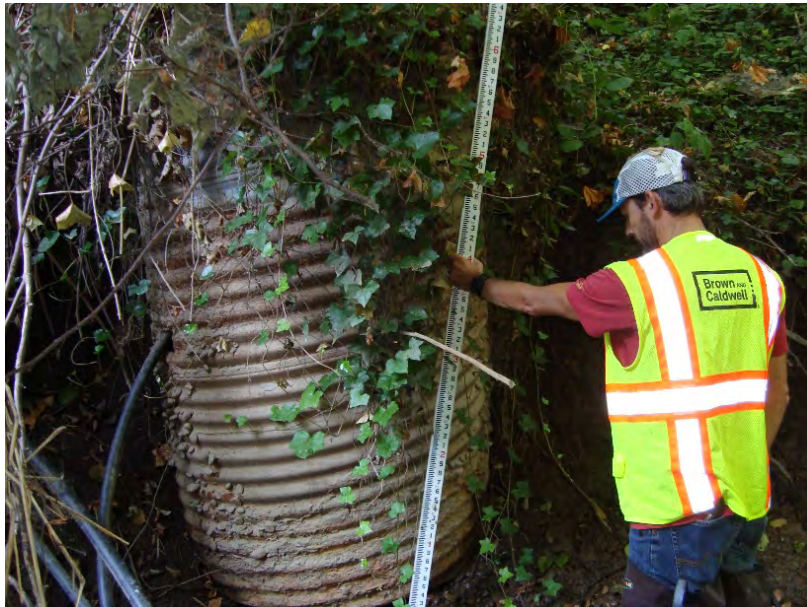
Site location: ~400' upstream from Tualatin River
Photo number: S1-4
Description: Corrugated steel pipe (former water intake?) on left bank

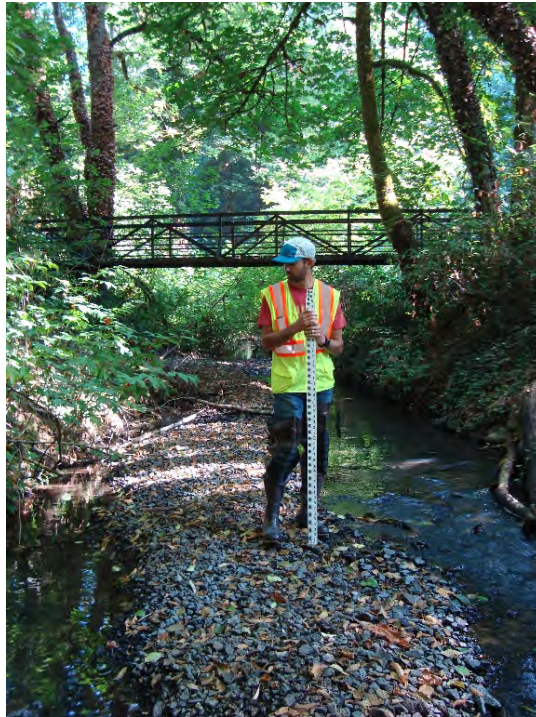
Site location: ~750' upstream from Tualatin

Description: Gravel deposition in bed (angular rock, construction debris?), pedestrian bridge in background, looking upstream

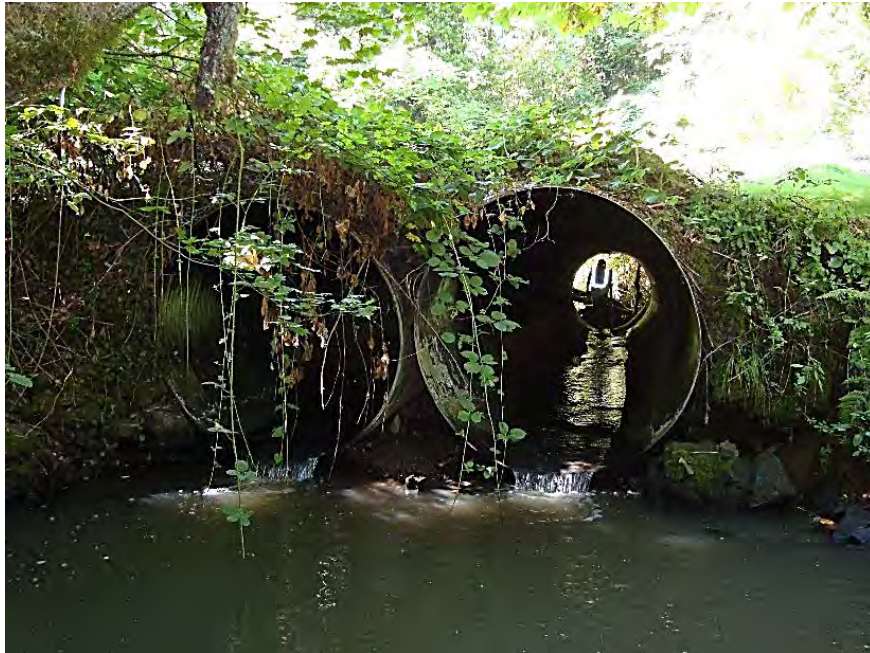
Site location: SW Halcyon Rd. culvert crossing
Photo number: S1-9
Description: Looking upstream- twin 6' culverts, plunge pool on downstream end

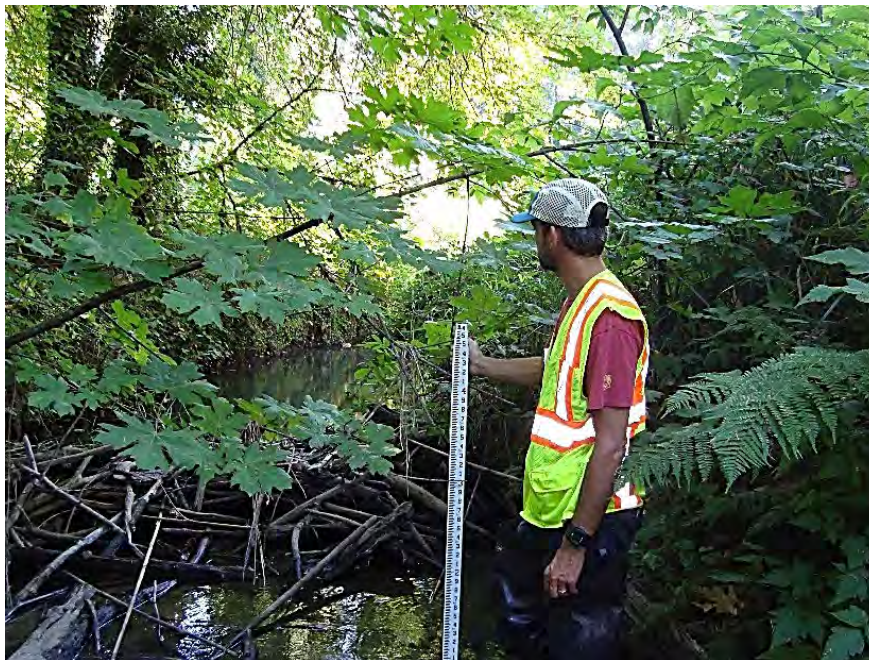
Site location: 850' upstream from SW Halcyon Rd.
Photo number: S1-14
Description: Looking upstream at beaver dam, debris on branches (high water mark near Ryan's right hand ~4.5 feet above channel bed)

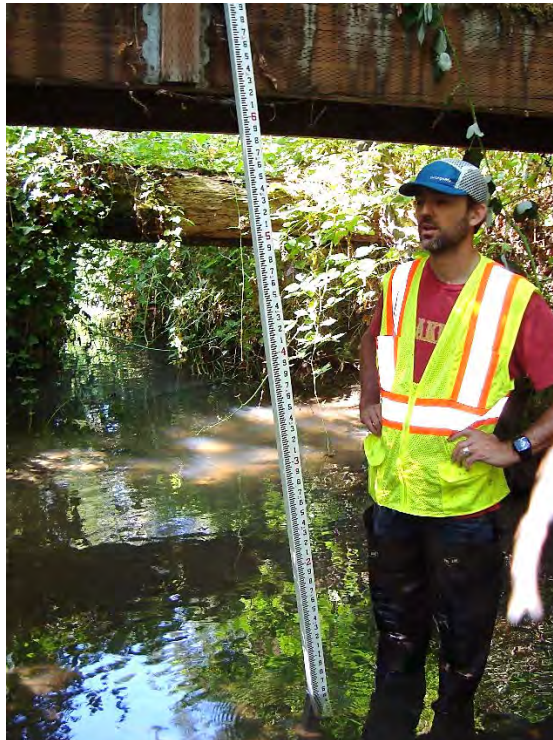
Site location: ~1,200' downstream from SW Borland Rd.
Photo number: S1-16
Description: Pedestrian bridge looking downstream, large tree down across channel in distance

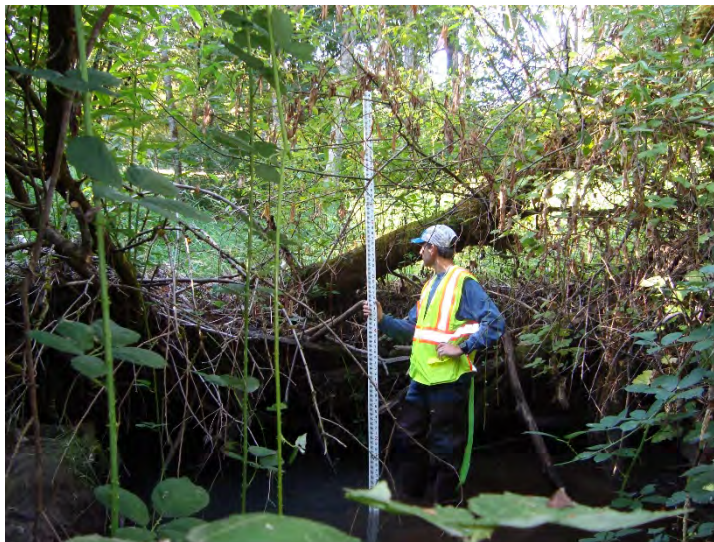
Site location: Between SW 55th and SW 56th, near I-205
Photo number: S2-4
Description: Channel spanning debris blockage, ~4' above channel bed, looking south and upstream

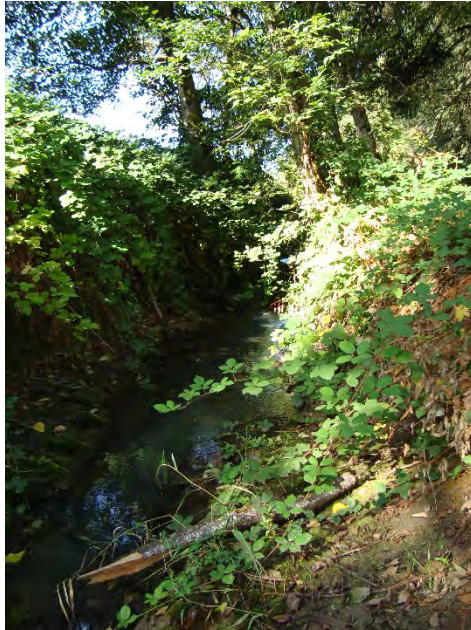
Site location: South of SW 58th, near trail project under construction
Photo number: S2-9
Description: Looking upstream- same location as Photo S2-8

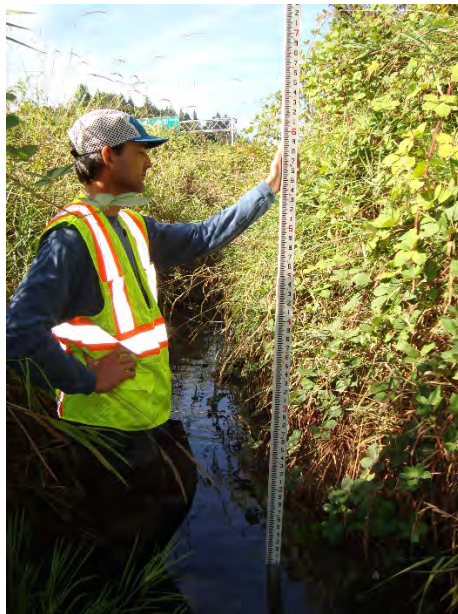
Site location: South of SW 59th
Photo number: S2-10
Description: Location of 12" steel pipe in channel disconnected from vertical segment. Some gravel in channel at this location.

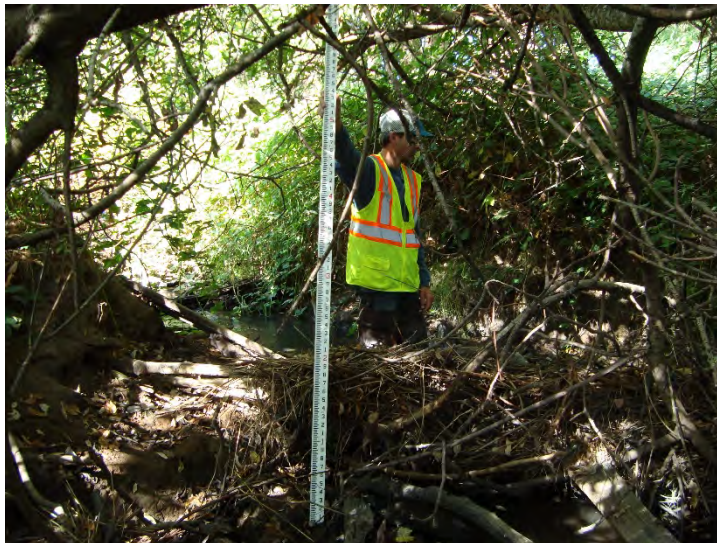
Site location: South of Sequoia Drive
Photo number: S2-12
Description: Debris jam

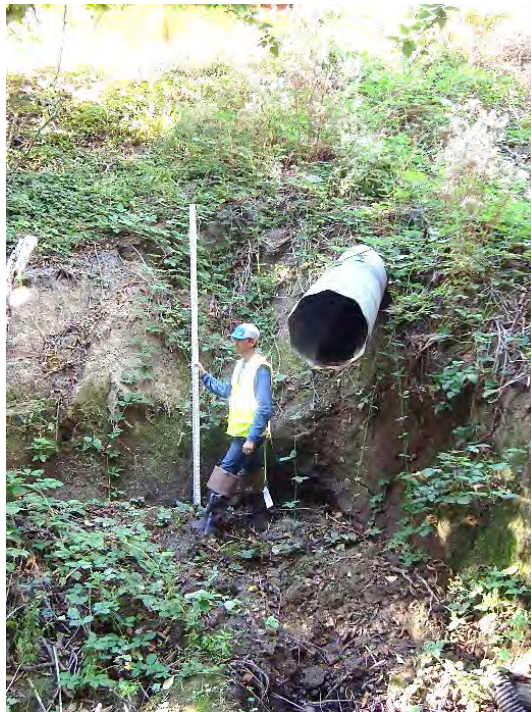
Photo number: S3-2

Description: Hillslope failure and perched culvert

Results of the stream assessment identified one location where a capital project may be developed to address City infrastructure potentially susceptible to failure. A perched stormwater pipe above the stream channel in Saum Creek Reach #3 was identified during the stream assessment. Stormwater discharge from this pipe will cause further erosion of the slope around it if left in its current position. A capital project is recommended to replace the pipe and repair the hillslope failure in the vicinity in conjunction with the pipe replacement. The new pipe should be placed on the hillside (i.e., thick-walled flexible pipe or similar) to the bottom of the slope, with energy dissipation provided. A geotechnical evaluation is recommended in order to determine the cause of the slope failure in the vicinity of the perched pipe, and provide input to the slope repair design.

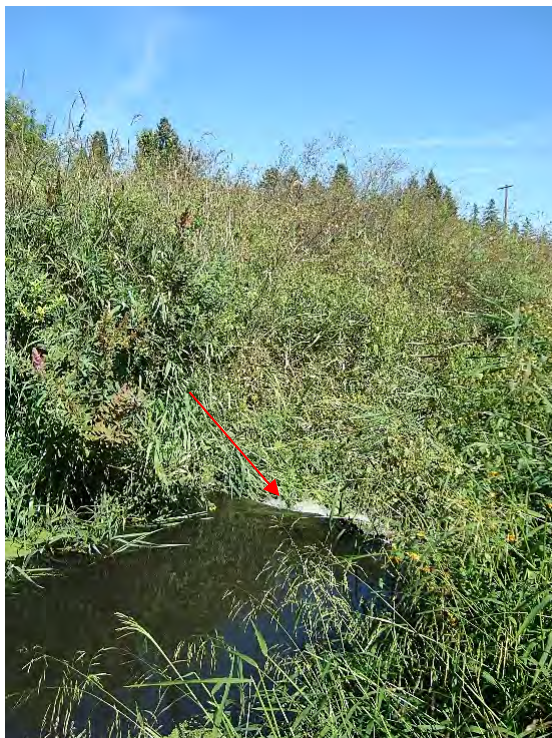
Site location: 400' upstream of SW Nyberg Lane
Photo number: N1-6
Description: Looking downstream at top of beaver dam. Red arrow points to top of dam. Drop is approximately 3 feet.

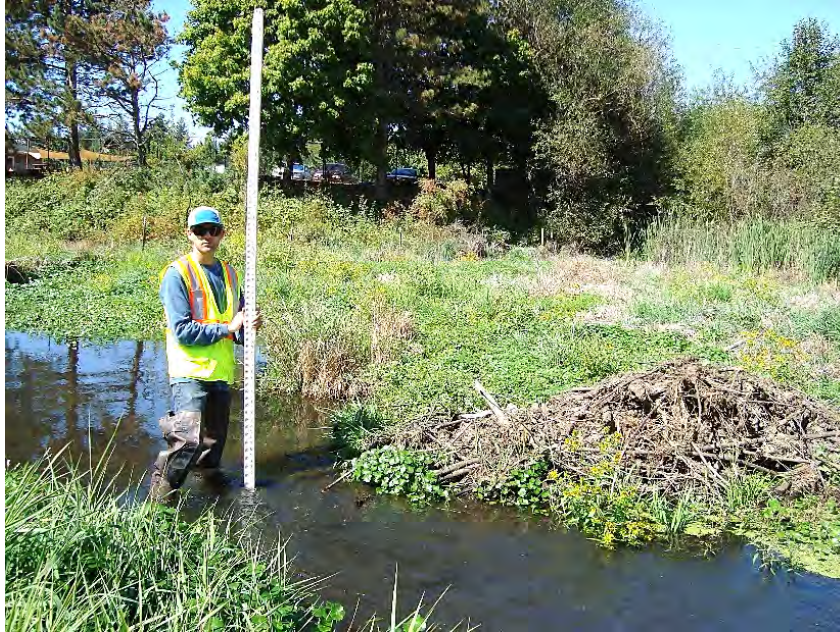
Site location: 450' upstream of SW Nyberg Lane
Photo number: N1-7
Description: Recently removed beaver debris

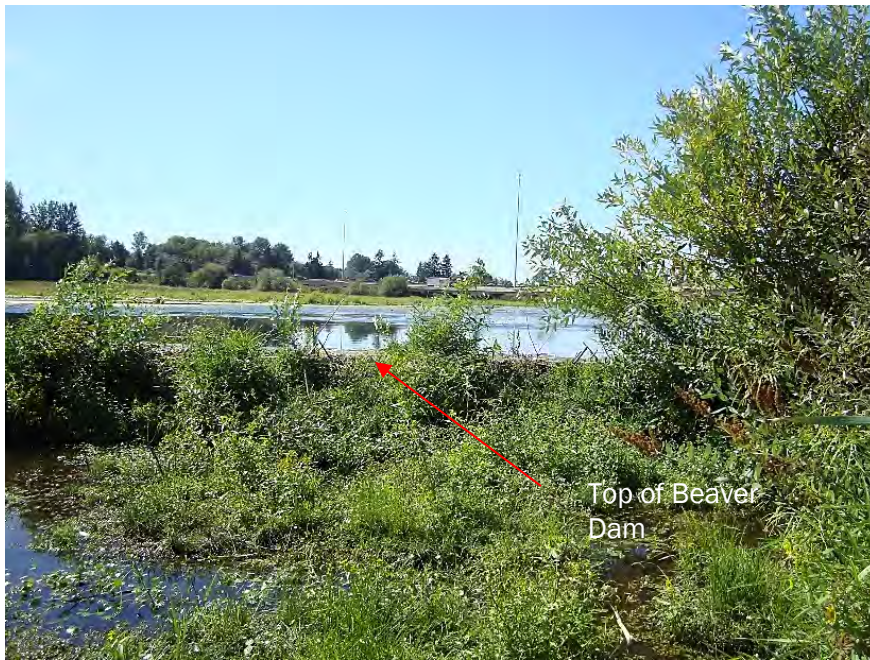
Site location: Downstream side of beaver dam
Photo number: N2-5
Description: Dam extends the entire length of valley bottom, creating a ~3 - 4' drop

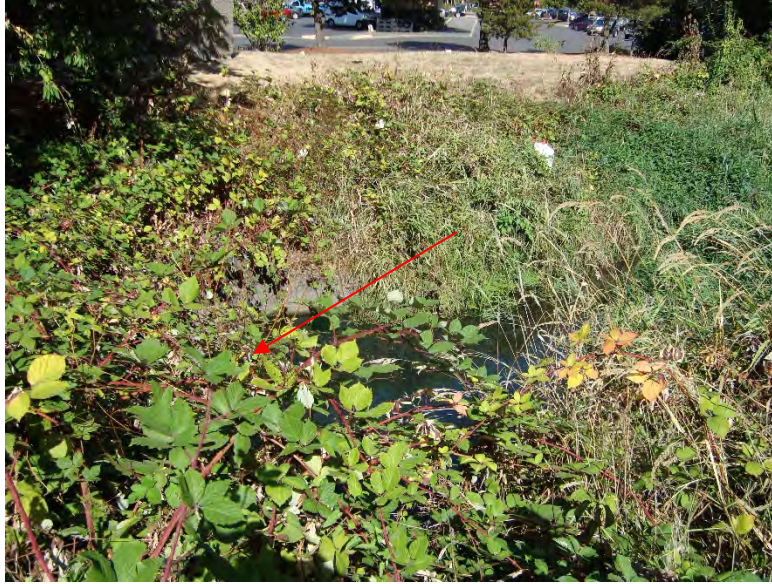
Site location: East side of SW SW Martinazzi Ave.
Photo number: N3-1
Description: Looking downstream of SW Martinazzi Ave. where 48-inch diameter stormwater pipe enters Nyberg Creek (approximately where red arrow is pointing)

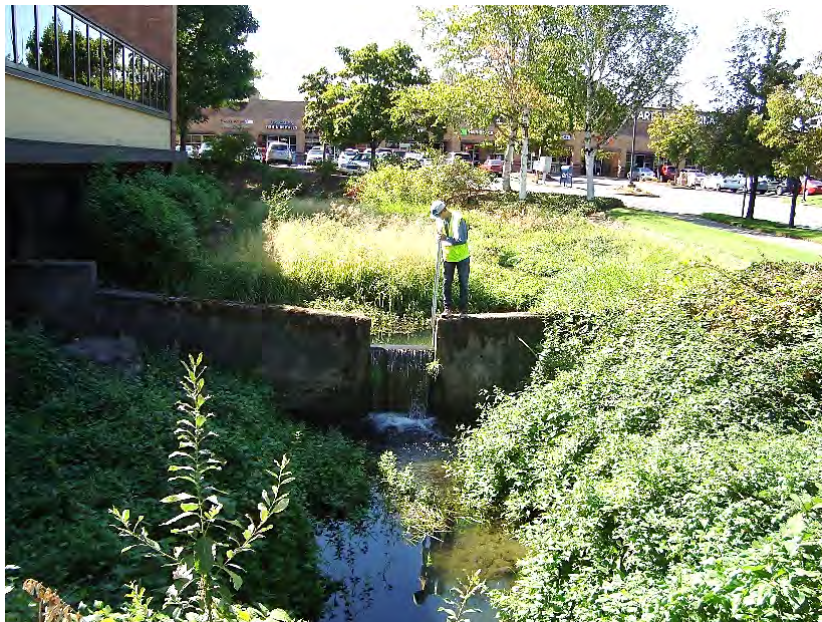
Site location: Upstream of SW Martinazzi Ave. by Shari's restaurant
Photo number: N3-2
Description: Nyberg Creek, concrete dam with notch

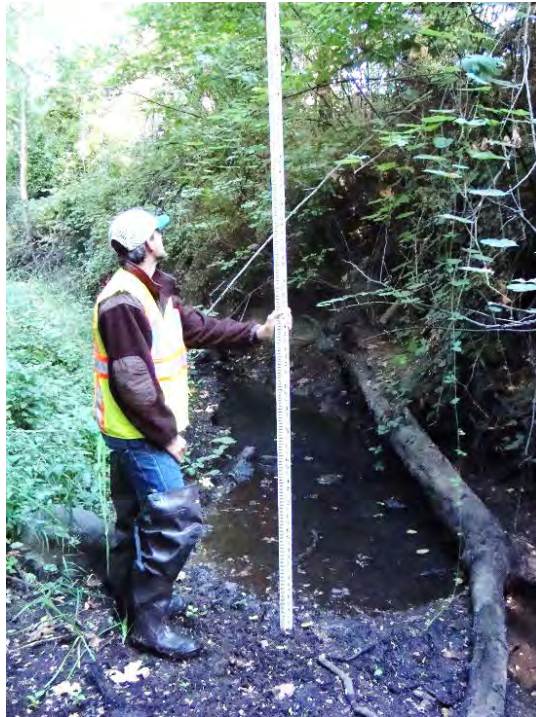
Site location: 100' upstream of Tualatin River
Photo number: H1-3
Description: Lots of silt in channel, gradient flattens

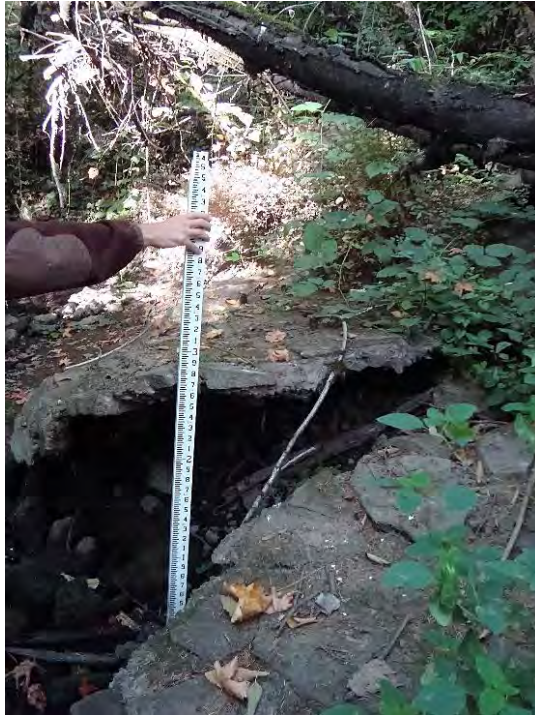
Site location: 200' upstream of Tualatin River
Photo number: H1-5
Description: Concrete poured in channel from left bank

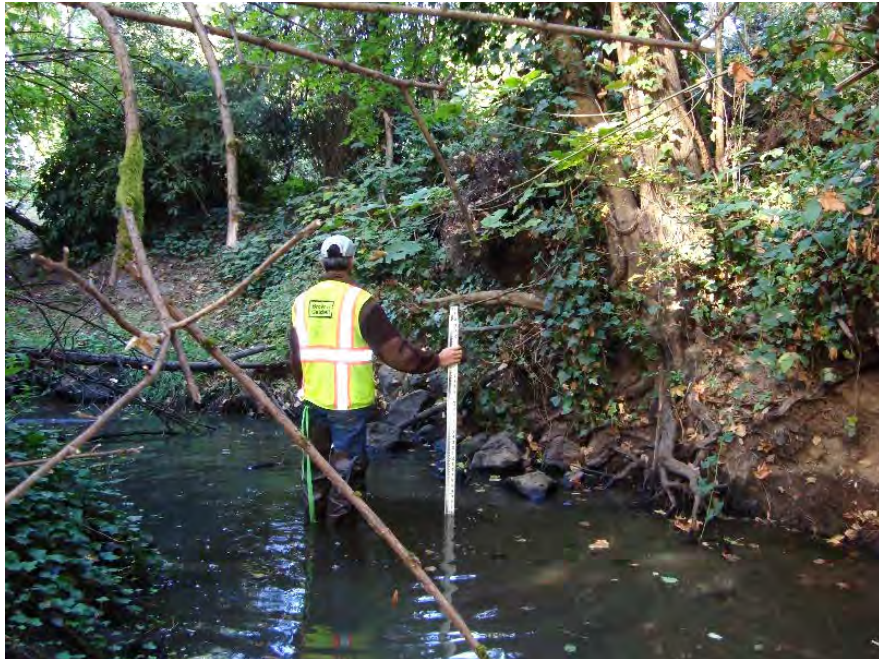
Site location: 450' upstream of Tualatin River
Photo number: H1-9
Description: Looking upstream, bank armoring on left bank (right side of photo)

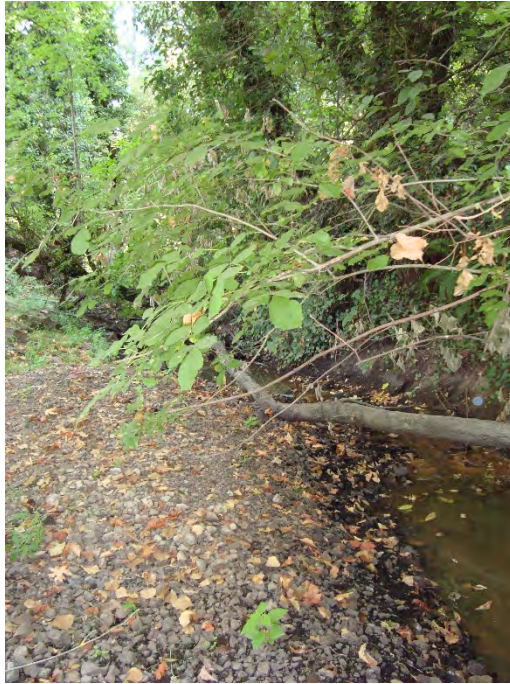
Photo number: H1-11

Description: Looking downstream at debris and creek, right bank (outside bend) is downstream of culvert constriction (washed out) where flow is concentrated. This area is vulnerable to erosion.

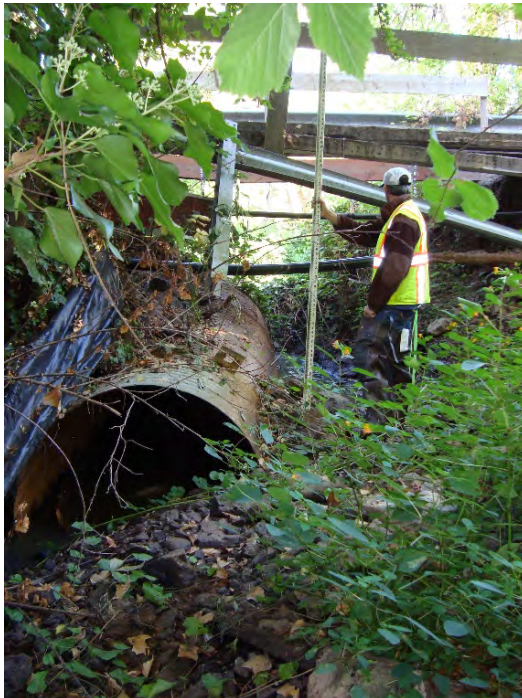
Photo number: H1-12

Description: Looking upstream at culvert under washed out bridge amongst debris that has not been removed

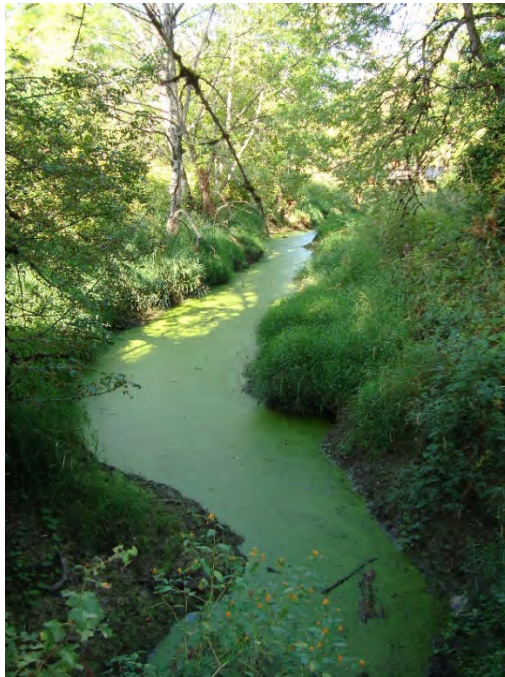
Photo number: H1-13

Description: Channel upstream of washed out bridge, stagnant water. Flow is restricted by debris and washed out culvert.

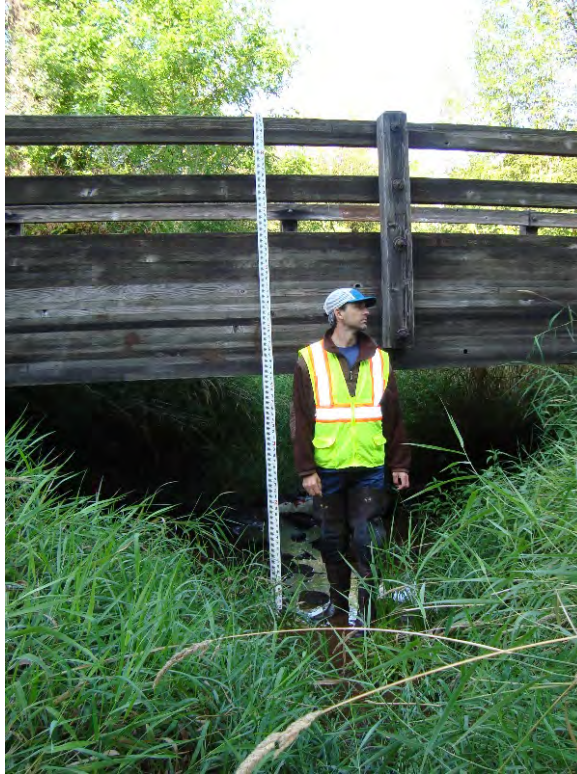
Photo number: H1-17

Description: Tualatin-Greenway bridge, channel choked with reed canary grass

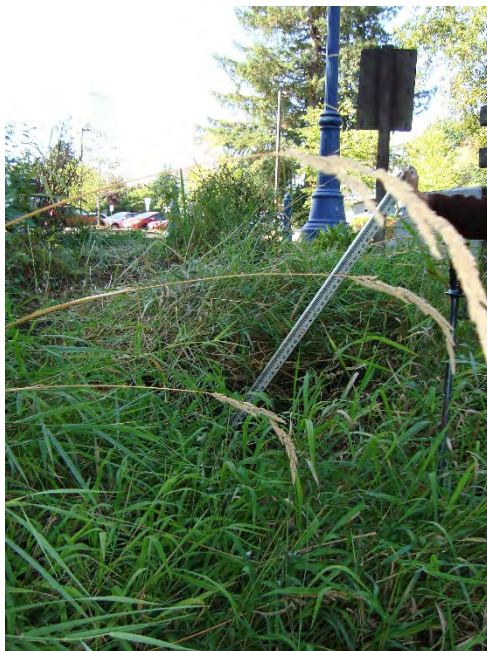
Photo number: H1-18

Description: Same location as photo H1-17. 18" diameter stormwater pipe enters channel on right bank where stadia rod is pointed.

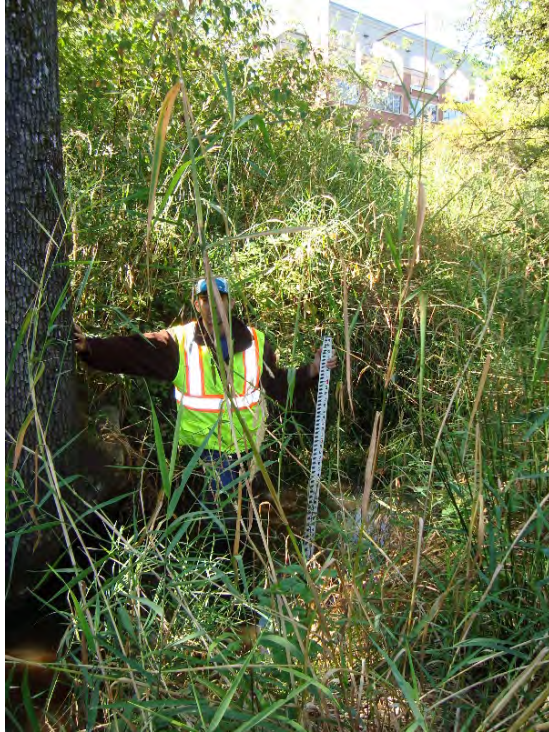
Site location: 1400' upstream of Tualatin River
Photo number: H1-19
Description: Looking upstream at reed canary grass choked channel.

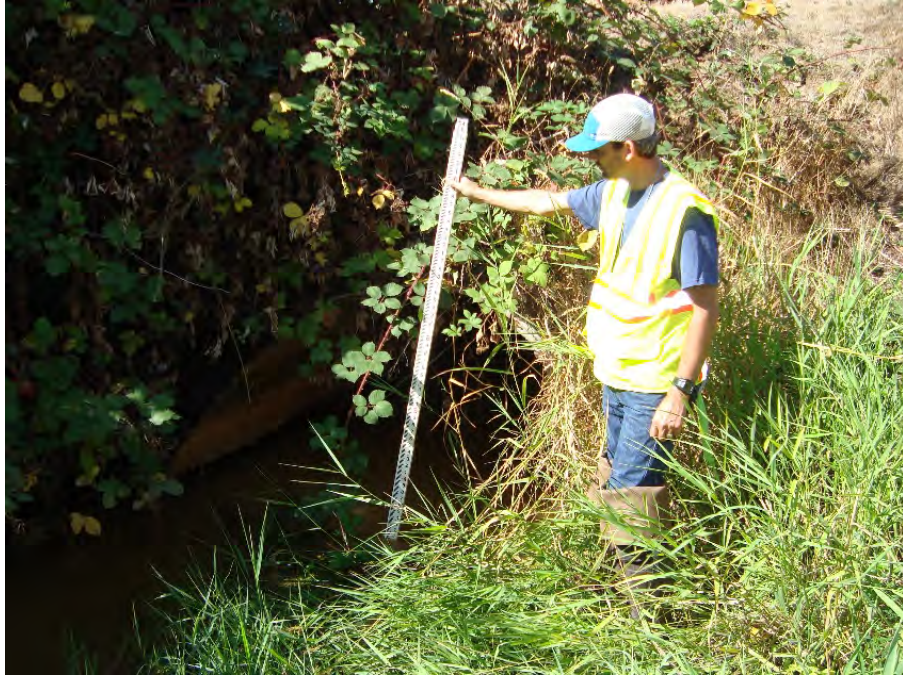
Site location: SW Boones Ferry Road
Photo number: H1-25
Description: Looking upstream at culvert under SW Boones Ferry Road

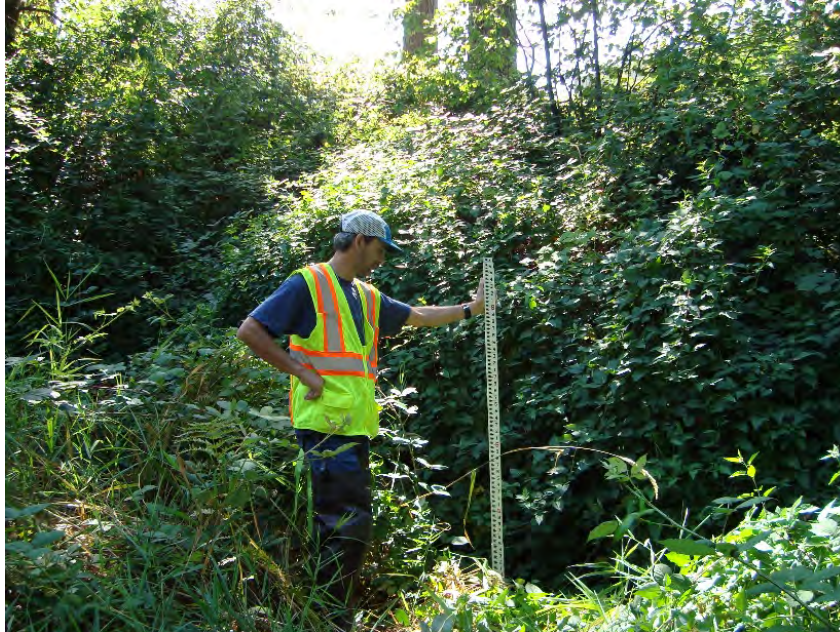
Site location: 650' upstream of SW Tualatin-Sherwood Road
Photo number: H2-7
Description: Channel location from top of bank (4' depth). Enveloped with blackberries and reed canary grass.

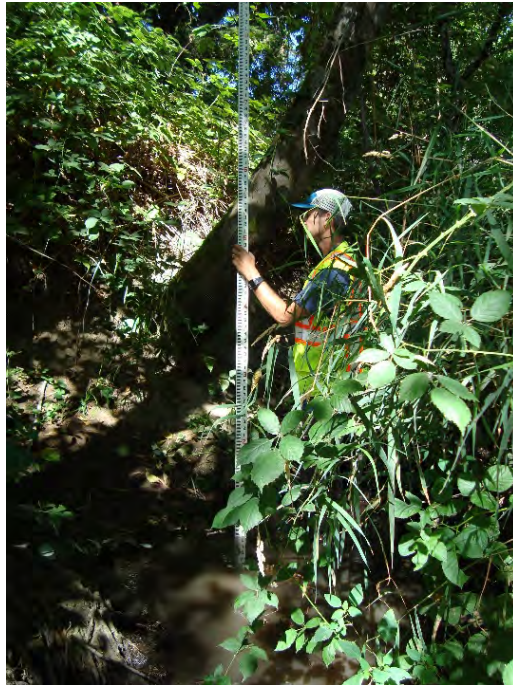
Photo number: H2-9

Site location: 900' upstream of SW Tualatin-Sherwood Road

Description: Looking upstream, exposed roots in channel. Left bank debris (high water ~4')

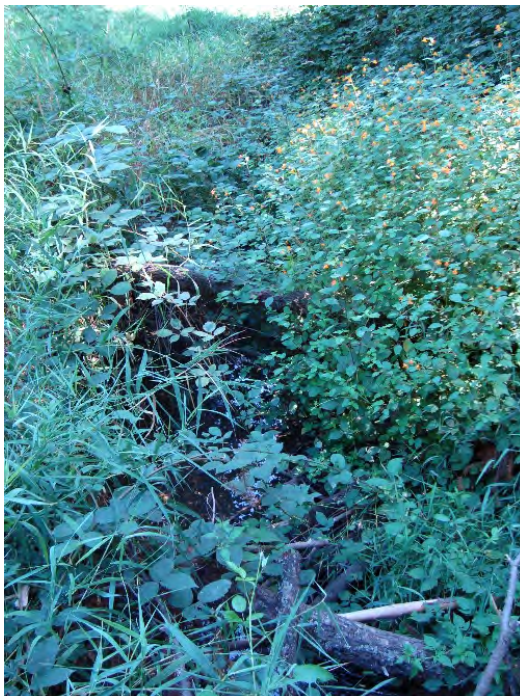
Photo number: H2-10

Site location: 1000' upstream of SW Tualatin-Sherwood Road

Description: Looking upstream, wide floodplain

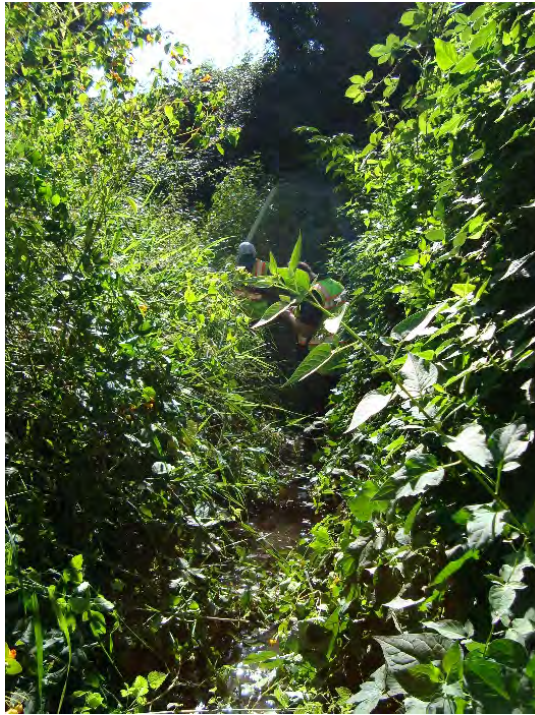
Photo number: H2-11

Site location: 1200' upstream of SW Tualatin-Sherwood Road

Description: Hard silt layer in channel

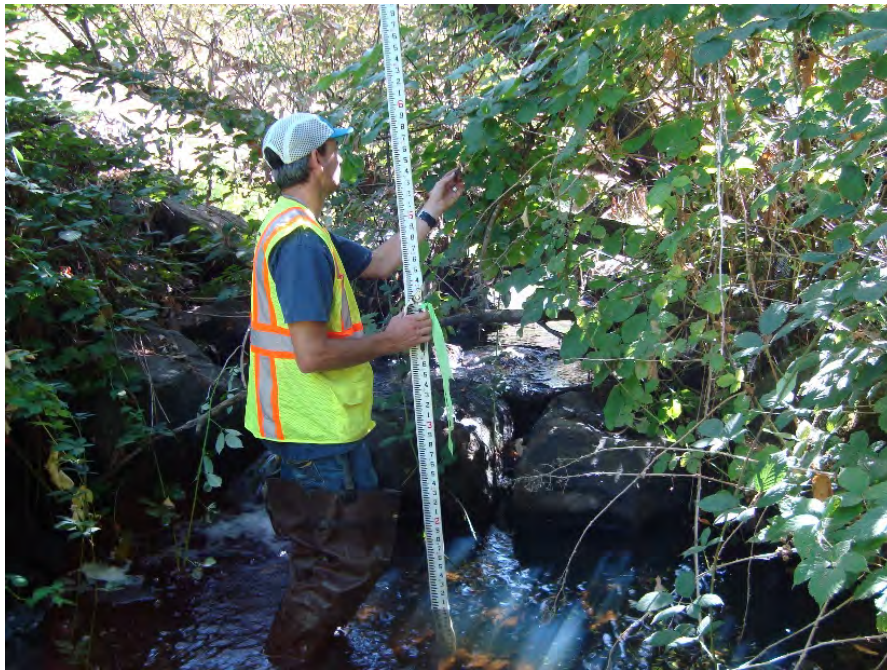
Site location: 100' downstream from SW Industrial Way
Photo number: H2-13
Description: Rock drop pool formed by rip-rap energy dissipation at culvert outfall

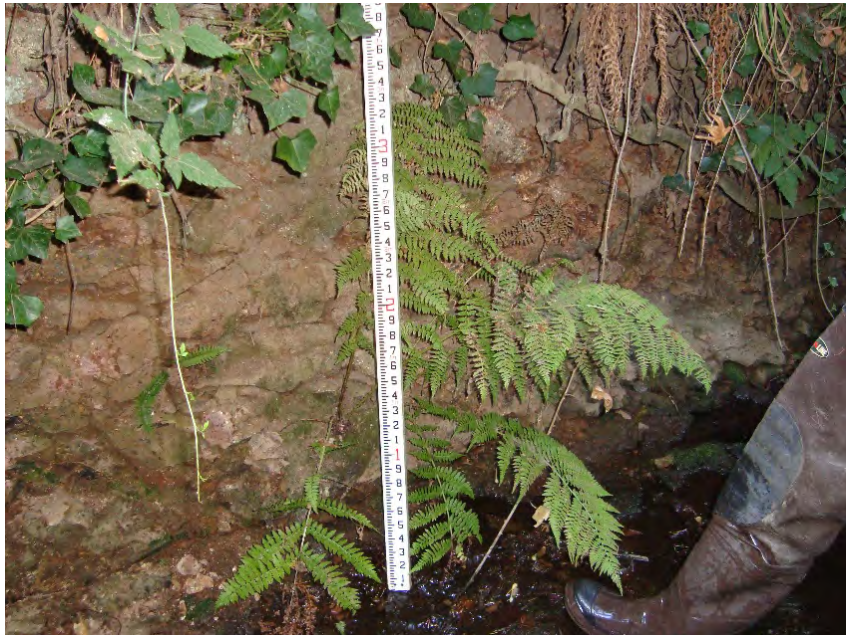
Site location: 500' upstream of SW 105th Ave.
Photo number: H3-6
Description: Bedrock outcrop in channel

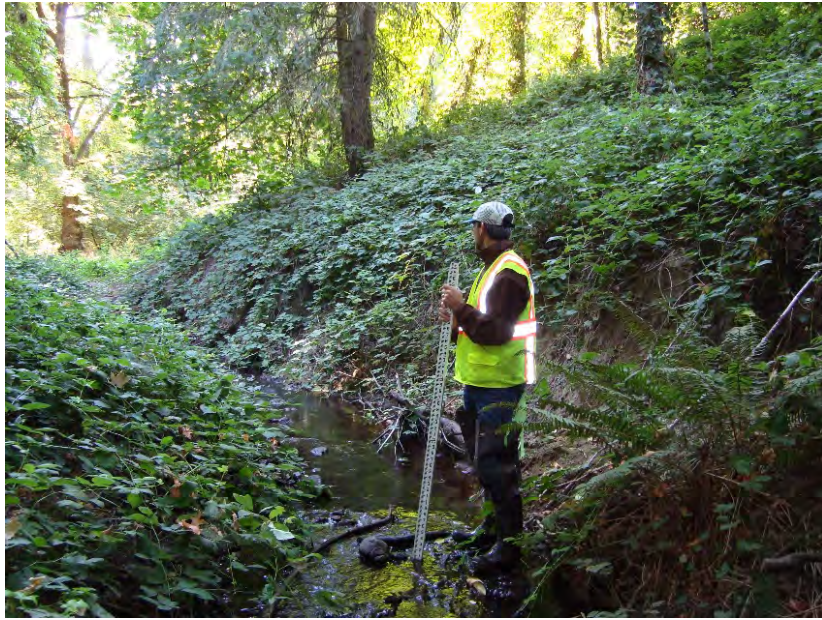
Photo number: H3-7

Site location: 550' upstream of SW 105th Ave.

Description: Looking upstream, bedrock channel

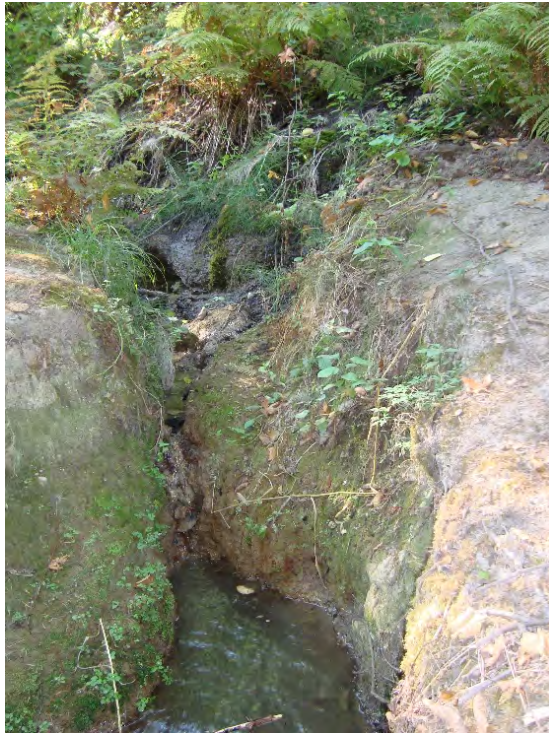
Site location: 750' upstream of SW 105th Ave.
Photo number: H3-10
Description: Side channel, left bank, deep incision, looking downstream

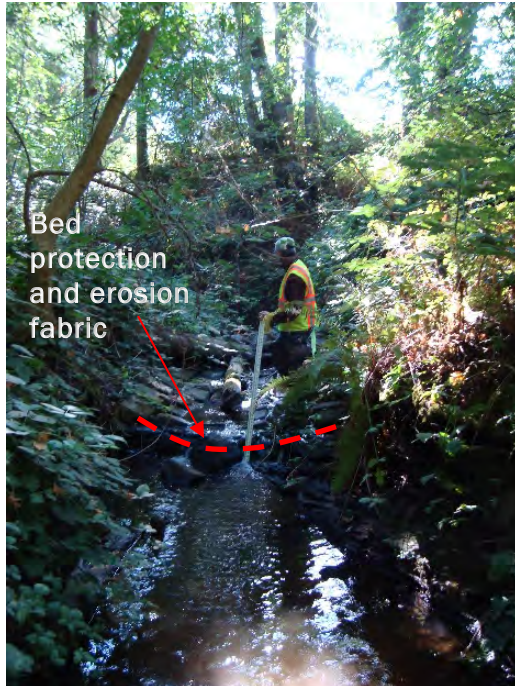
Photo number: H3-18

Site location: 1350' upstream of SW 105th Ave.

Description: Bed protection and erosion fabric (restoration area)

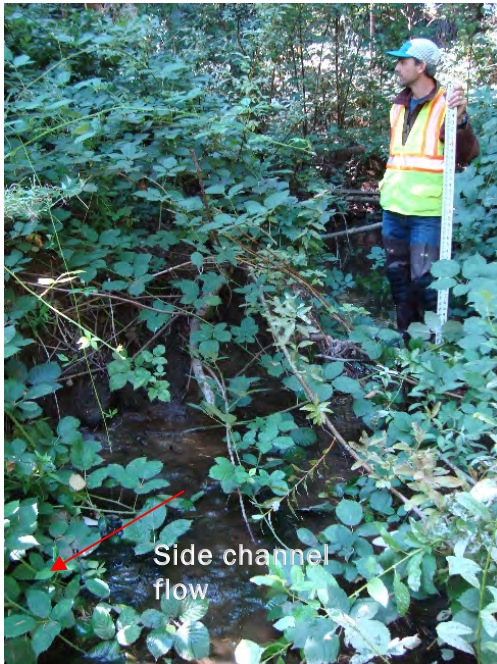
Photo number: H3-20

Site location: 400' downstream from confluence with S. Tributary

Description: Looking upstream, flow is coming in from right bank (very small channel not visible from left side of photo), stagnant water in this location

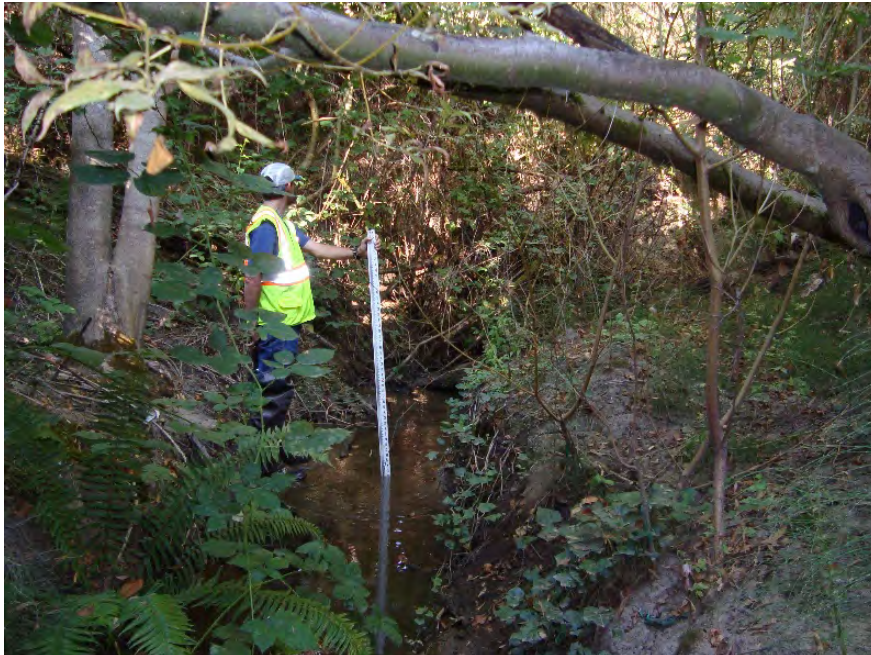
Site location: 300' upstream of confluence with S. tributary
Photo number: H3-24
Description: Looking upstream, hard silt in channel, incised

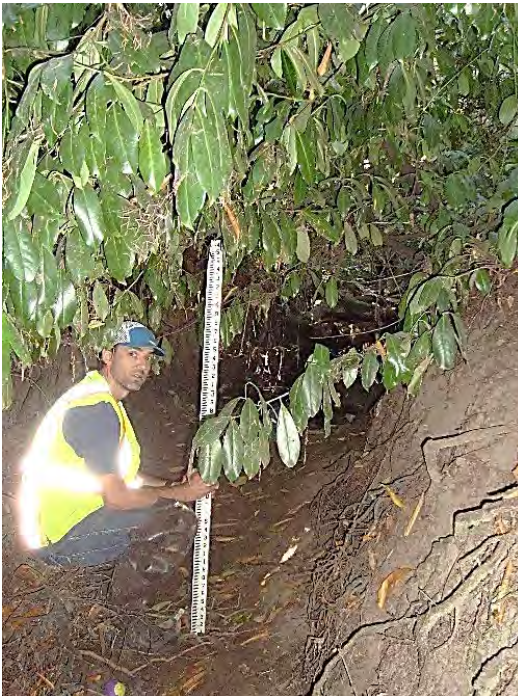
Photo number: H3-29

Description: Looking downstream, upstream of SW Alsea Ct. Dry channel.

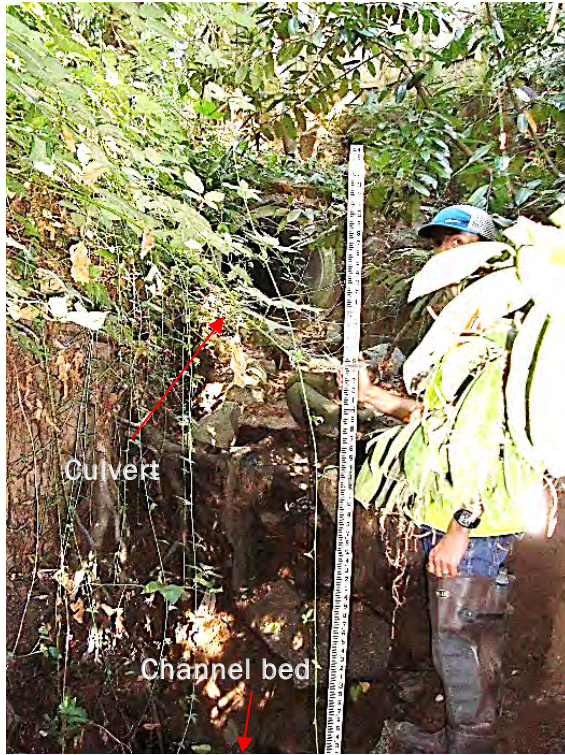
Photo number: H3-30

Description: Looking upstream, narrow defined channel, dry
